(Final Report, Revised November 28, 2017)

**Condition Assessment
&
Reserve Fund Plan
2017**

NEW MARK COMMONS

Rockville, Maryland

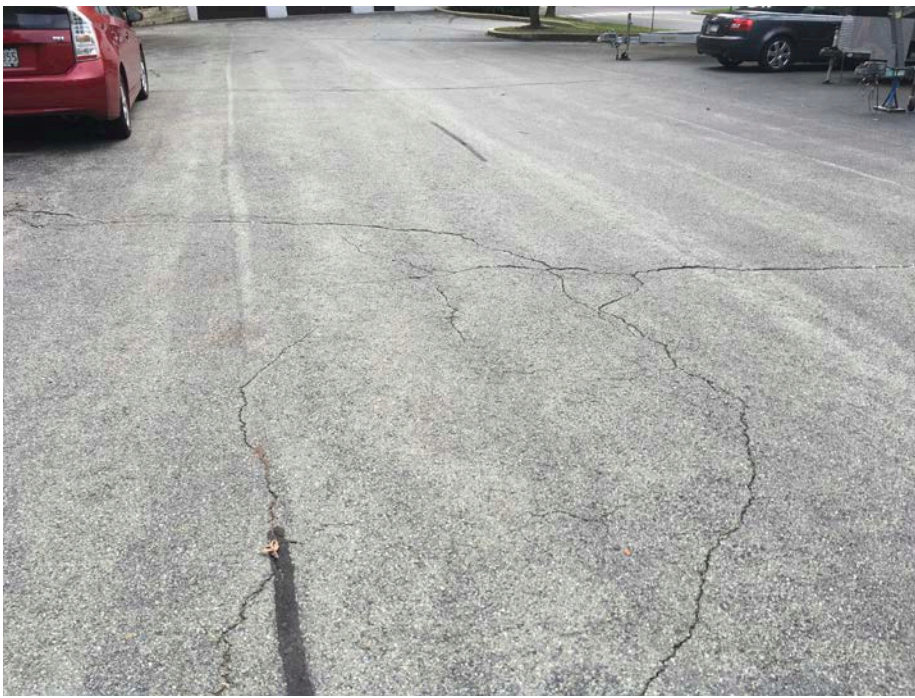
PHOTO #1

The asphalt throughout the community center parking lot and all five courts is in generally fair to poor condition with wide area cracking and deflection. The asphalt has been maintained throughout its service life and according to Management has far exceeded its projected service life.

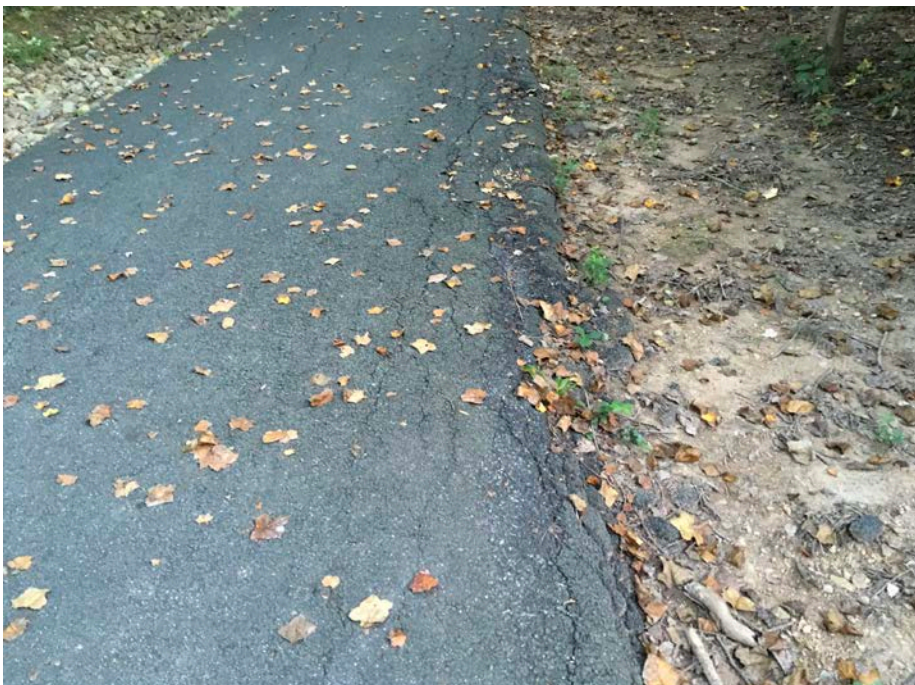
PHOTO #3

The asphalt footpaths are in generally good condition and have been repaired over the years. However, we observed some shoulder deflection and tree root damage, which should be addressed at some point. We have scheduled the worst 25% of the footpaths to be replaced every five years such that full replacement is accomplished during the 20-year projected service life.

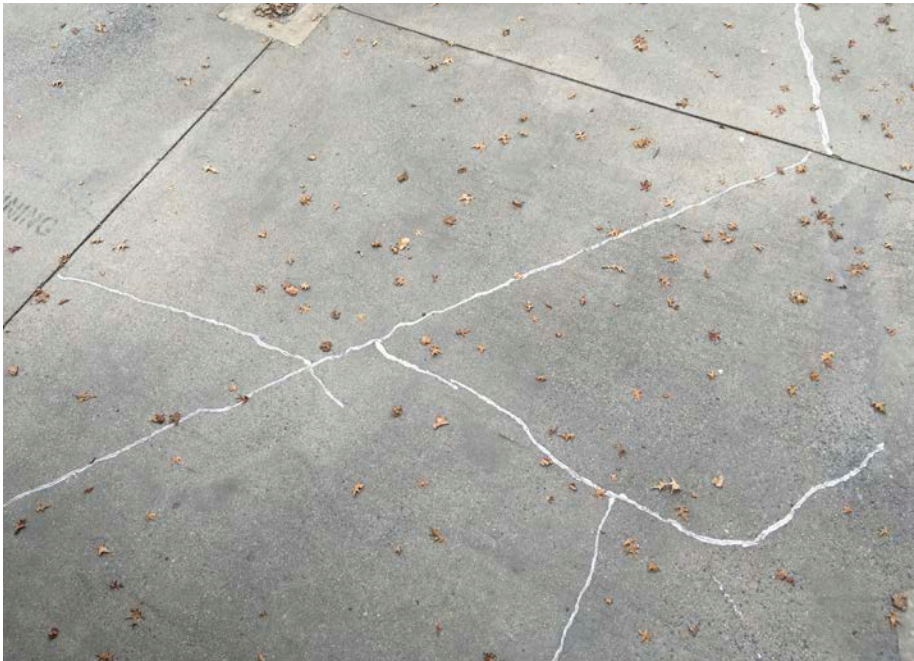
PHOTO #5

The concrete pool deck is nearing the end of its service life and has failed a recent inspection. Due to financial constraints, we have scheduled a repair project rather than full replacement in 2018. A full replacement project has been scheduled to coincide with the pool renovation and modernization project mid-term.

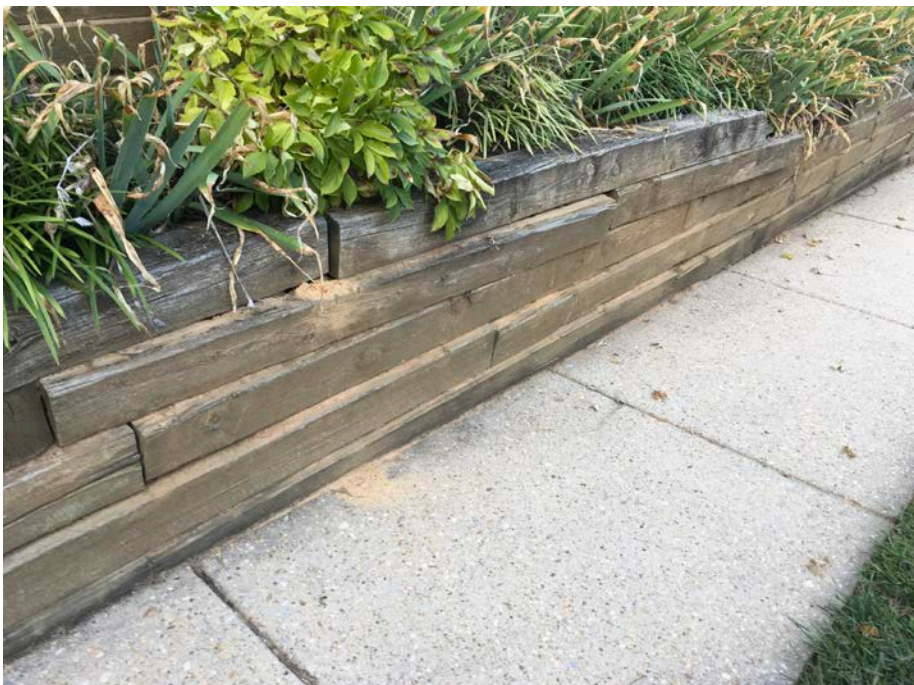
PHOTO #6

The pressure-treated timber retaining walls are in generally very poor condition. We have scheduled all walls to be replaced over the next four years.

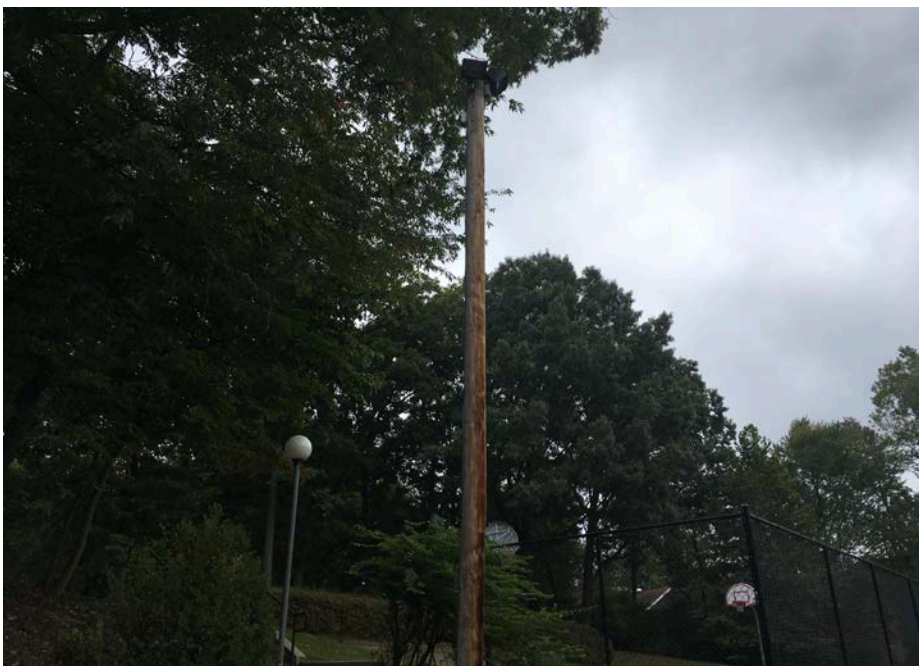
PHOTO #8

The light poles and fixtures throughout the site are maintained in-house and appear to be in serviceable condition. No problems were reported with the various lighting system.

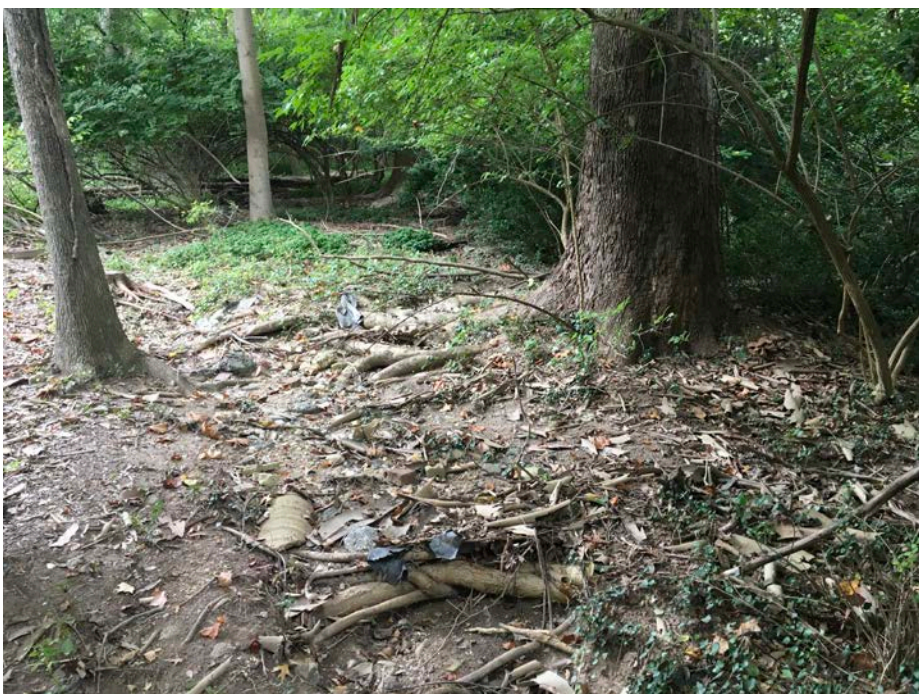
PHOTO #9

Erosion has been a problem in four locations. We understand that a storm water management system and erosion remediation project has been scheduled for 2018, and will be managed and designed by Earthman Design Group, LLC. The project is expected to exceed \$129,000.

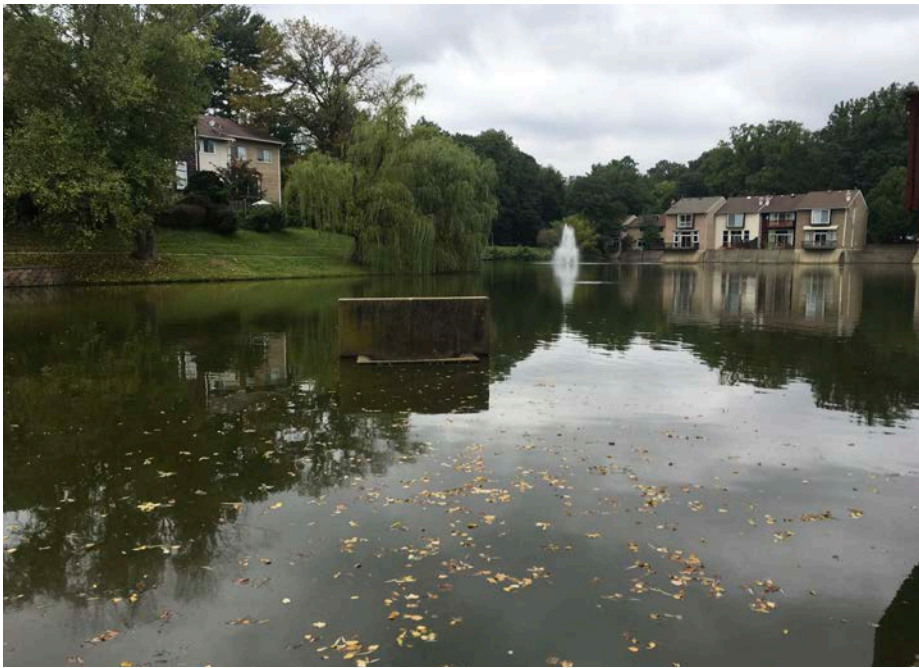
PHOTO #10
The pond and ancillary components appear to be in generally good condition and well managed. Approximately \$300,000 was spent on the pond in 2004. It is critical that the association be funding reserves at adequate levels as it is likely that future dredging and other pond related issues will result in a similar expenditure within the next 30 years.

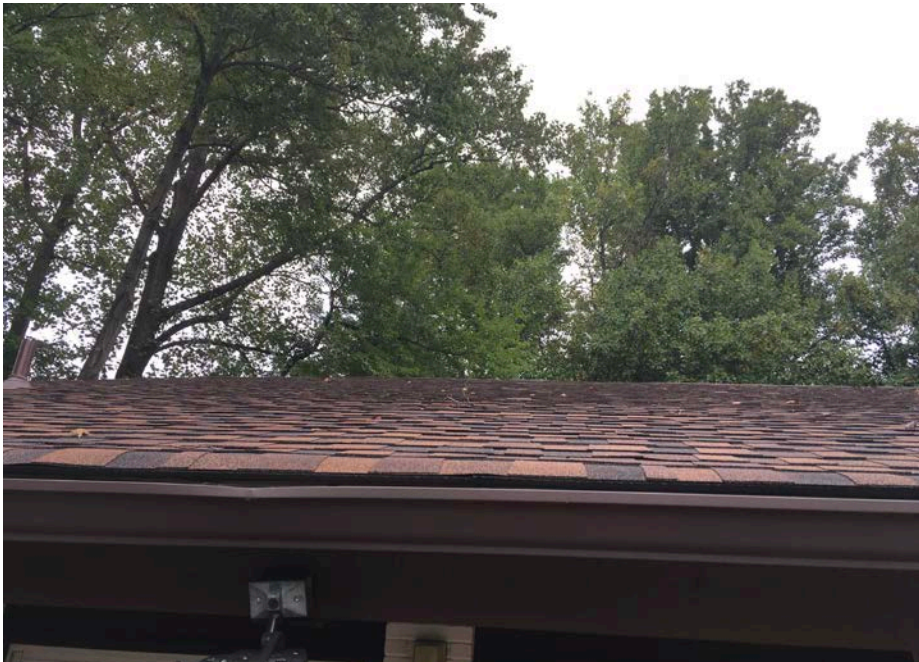
PHOTO #11
The asphalt shingle roofing was replaced in 2016 and appears to be in excellent condition with no deficiencies observed.

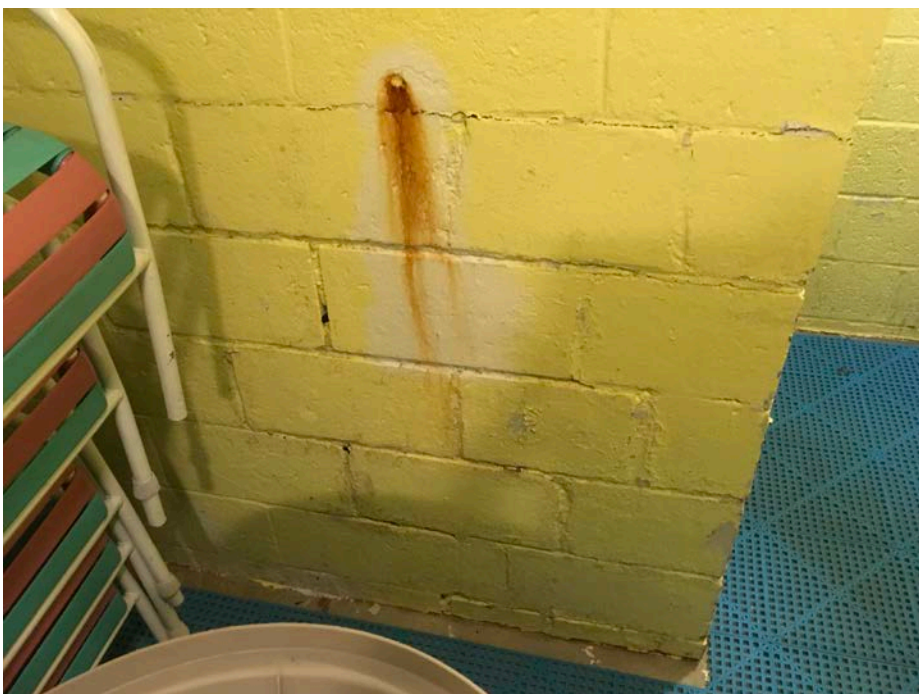
PHOTO #12
The bathrooms and shower rooms are in generally dated condition. We have scheduled a refurbishment project near-term to update the interior components and replace damaged and deteriorated doors.

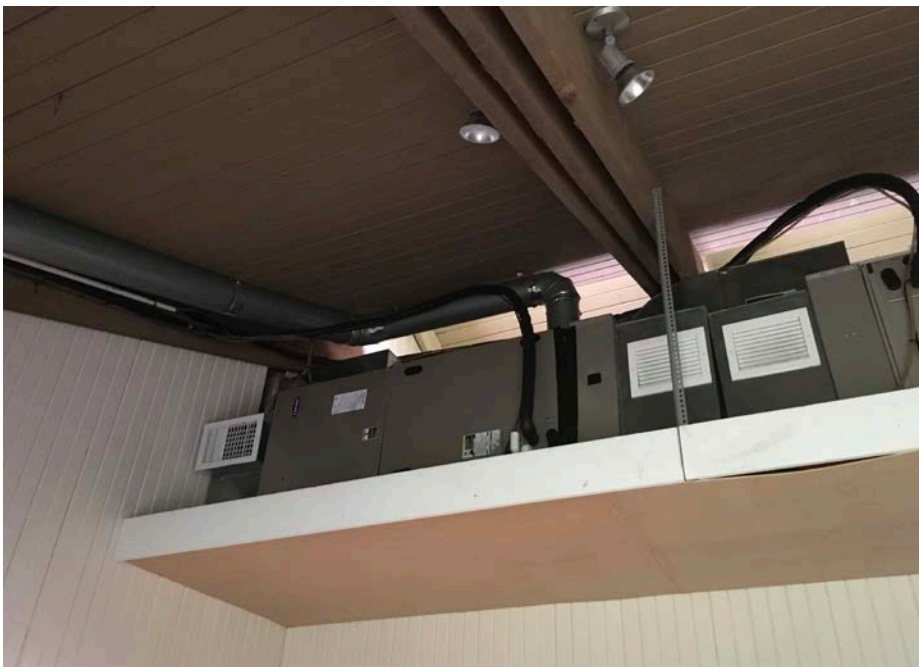
PHOTO #13
The HVAC and furnace systems were newer, very well installed, and fully operational during the evaluation.

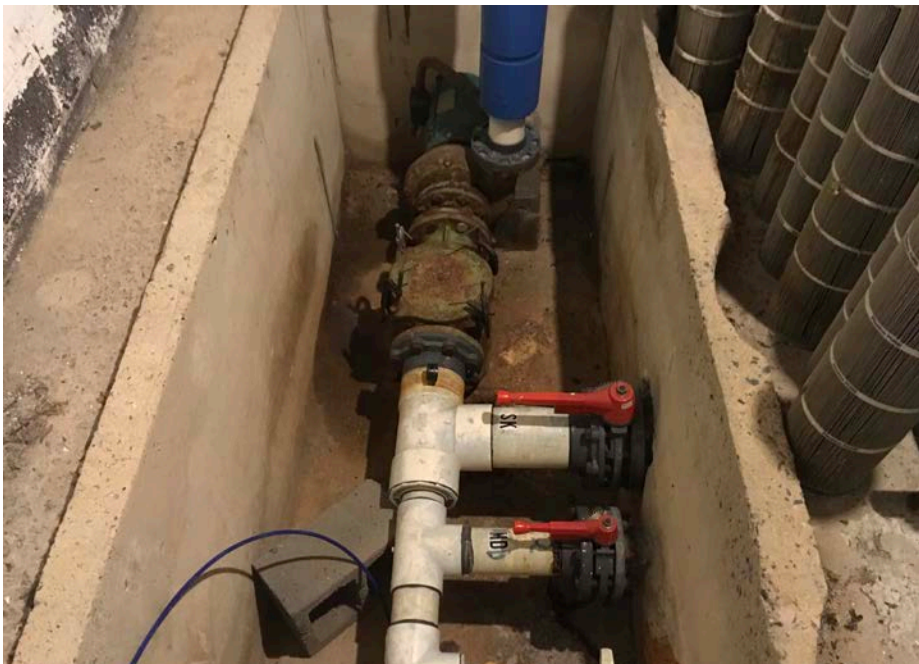
PHOTO #14
The pool water filtration systems for the main pool and wading pools were reported to be in good working order, though the main pool pump and strainer assembly appear to be somewhat dated. We have scheduled a replacement project after a typical service life.

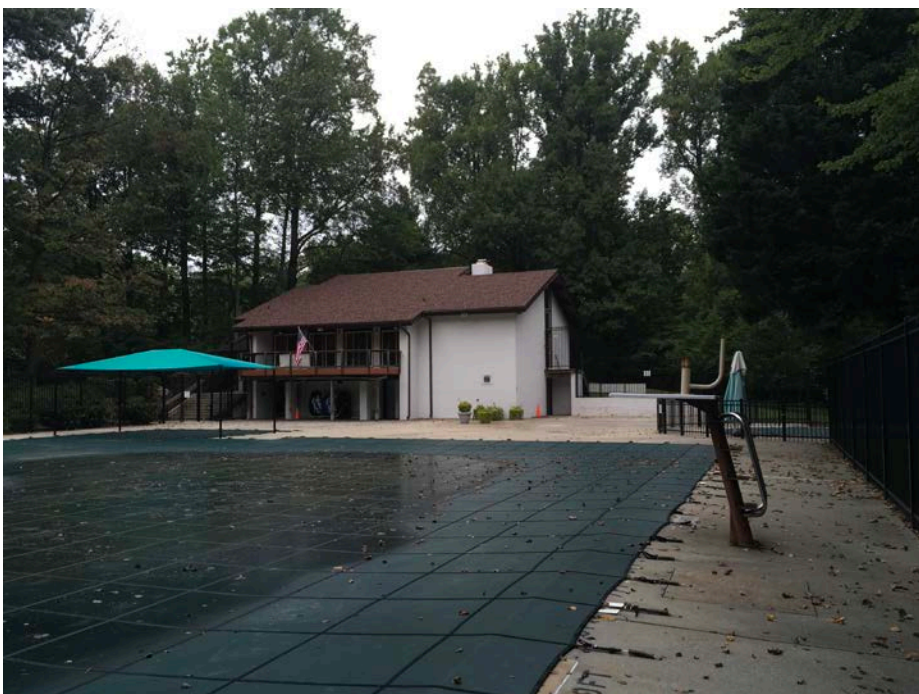
PHOTO #15
The pool was covered for the season. However, it was reported that the pool was coated, received new coping, caulk, and water line tile in 2013. We have scheduled a pool modernization project mid-term, which should include the replacement of the pool deck, ancillary equipment, and modern ADA accommodations. The pool was reported to be in good condition.
