April 27, 2018 - Revised

**Re: New Mark Commons, Rockville, Maryland  
Site Assessment for Drainage Improvements**

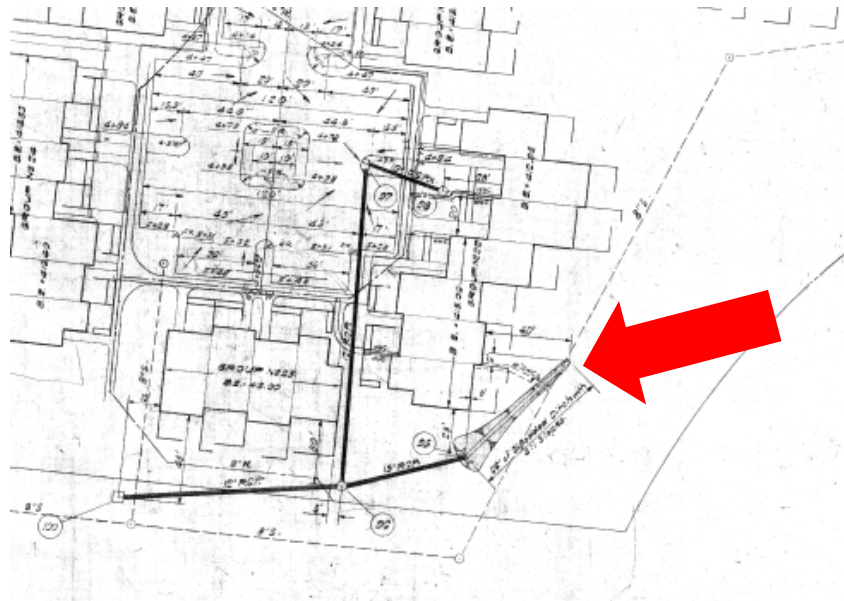
We reviewed a limited number of drawings for the property which were made available to us from Abaris Realty. We have attempted to get copies of additional site plans, specifically a clear/detailed topographic plan, for New Mark Commons from the City of Rockville. To date these attempts have been unsuccessful and the provided topographic plan (from Abaris) is of insufficient detail to meet our requirements. Of the drawings provided by Abaris, it is clear that NMC has the beginnings of a Storm Water Management System but it has not been fully implemented. By that, we mean there are storm water inlet/outlets at the parking lots but these typically discharge and rely on an incomplete swale “system” to move the water to the discharge points (i.e. the pond). It is not clear that this system was permitted at the various times that it was constructed or augmented.

Exhibit 1: Showing incomplete SWM facilities, SWM pipe simply discharges to the ground

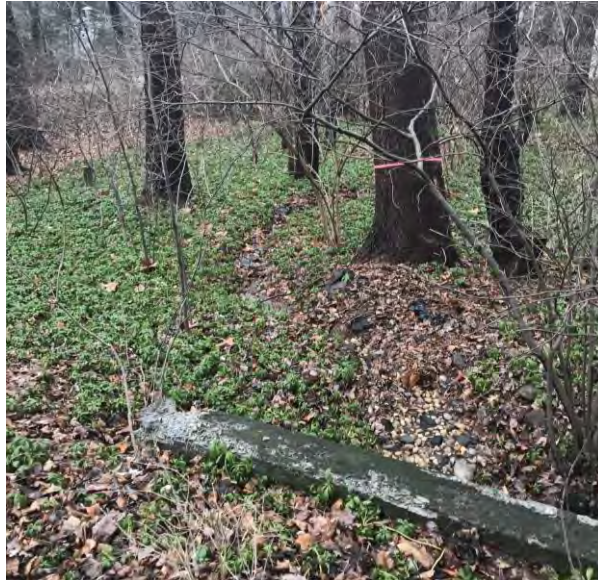
**Area #1:** was described as “The rear of 338-342 New Mark Esplanade (NME). The low area where runoff has created several water paths that are exposing tree roots and creating erosion channels”.

**Recommendation:** Have an arborist review all the trees and remove any suspect/questionable trees. Install a retaining wall at the rear of 338 NME to alleviate ongoing erosion. Within the swale, clear out existing dead trees/debris/and saplings. Install GeoWeb (see photograph below). Install two or more stone check dams to slow / detain water in the swale. It is important to slow the water but not hold it long enough to breed mosquitos. Modify the slope of the swale as necessary to ensure that water reaches the pipe that extends beneath the street. This should continue back as far as the bike path.

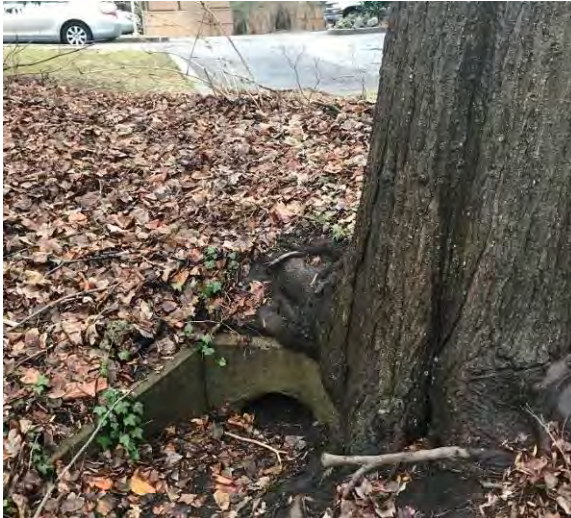
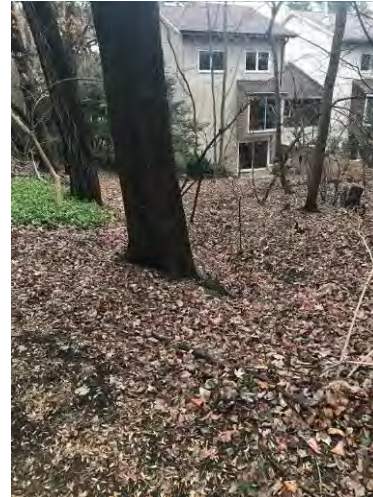
**Area #2:** was described as “Contributing to the Area #1 problem is the wooded area on the side of 508 and 516 NME. Runoff from the parking lot has created erosion channels which have impacted the area behind 338-342 NME”

**Recommendation:** Adjacent to 508 NME, we recommend removing the tree at the parking lot SWM outlet. The RCP is likely to be damaged and may require replacement. The swale should be reconfigured to more efficiently collect and retain water. Install GeoWeb in the swale to prevent erosion. Direct water to the existing, rock-lined swales along the bike path. Due to shade from the heavy tree canopy in area, a vegetated swale is likely not feasible. Accordingly, the photograph below depicts GeoWeb with stone.

Adjacent to 516 NME, we recommend a similar scope of work. We recommend creating a swale to capture the water that outfalls at the cut in parking lot curb. The swale would direct water to the existing rock-lined swales along the bike path. Some tree removal will be required to allow for the installation of the new swale.

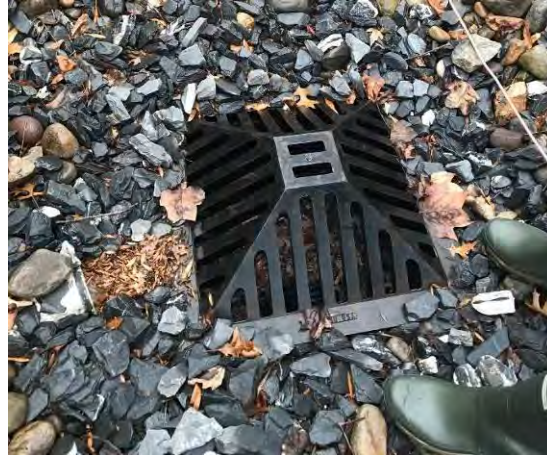
**Area #3:** was described as “The area behind 300-314 NME, concentrating on the area behind 300-306 NME. Storm water runoff from the area between the bike path and the rear of these homes needs to be mitigated.”

**Recommendation:** The issue is not that water cannot reach the area but rather that it picks up debris and clogs the storm drain grate. We recommend a thorough cleaning/jetting of the SWM in this area and more frequent cleanup of debris (i.e. leaves, sticks, etc.) to help prevent accumulation at the grate. We would also propose implementing Flowells to capture a portion of the runoff from the adjacent roof areas. Alternate items to prevent water from reaching the storm drain can be considered if the problem persists. Foremost among these would be a detention / infiltration basin. An infiltration basin would be designed to collect and infiltrate water over a period of two to three days, but not long enough to allow insect breeding or to require ongoing maintenance such as aeration. The photograph below shows a vegetated infiltration basin which functions by having water-loving plants absorb the collected water. As noted above, the current tree cover would prevent these plants from thriving in a similar structure at New Mark Commons.

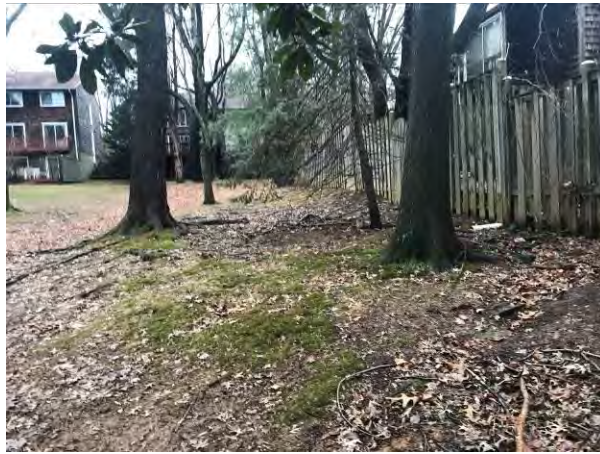
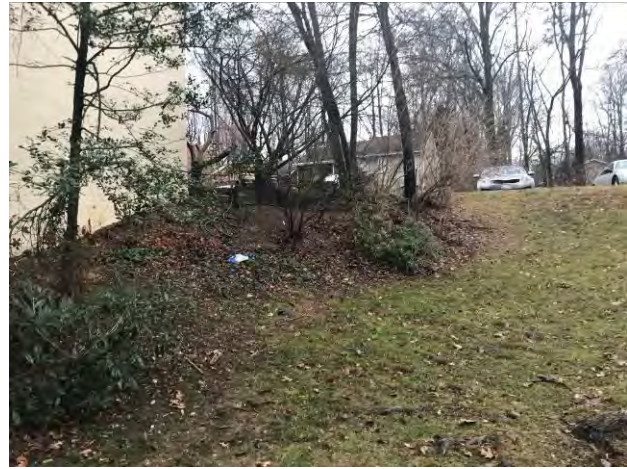
**Area #4:** was described as “The hill side next to 276 NME requires stabilization, additional planting, and an existing surface drain needs to be repaired.”

**Recommendation:** Due to the steep slope in the area, one surface drain is insufficient to capture the runoff. Accordingly, we recommend that a series of gravel swales be installed to divert water into the existing channel on the boundary line. One of the swales could extend to capture the water to the north of 276 NME. The photograph below is an example of such a swale. The residence 276 NME has been identified, by NMC, specifically as requiring a retaining wall. A retaining wall could be installed, however there are several factors to consider. These include the wall's location on residential versus common area property, tree removal to allow for the wall installation, and below-grade waterproofing of the foundation wall of the residence with re-grading. If there are ongoing concerns related to house-settling, a retaining wall may not be the solution. We recommend resolving those items prior to commencing with installation of a retaining wall.
