April 27, 2018 - Revised

**Re: New Mark Commons, Rockville, Maryland  
Site Assessment for Drainage Improvements**

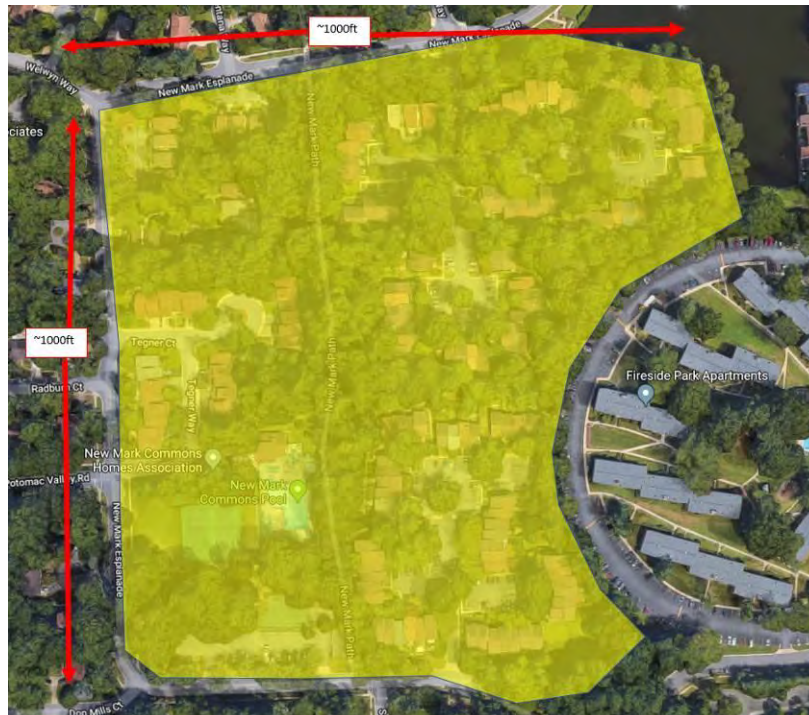
Exhibit 2: Location of Aerial Survey

We contracted with Potomac Aerial Surveys to perform an aerial survey of a portion of New Mark Commons. The surveyed area was the townhouses bounded by New Mark Esplanade and included the areas noted below. We have included a copy (at the end of this report) of the topographic survey with the intended SWM improvement areas highlighted.

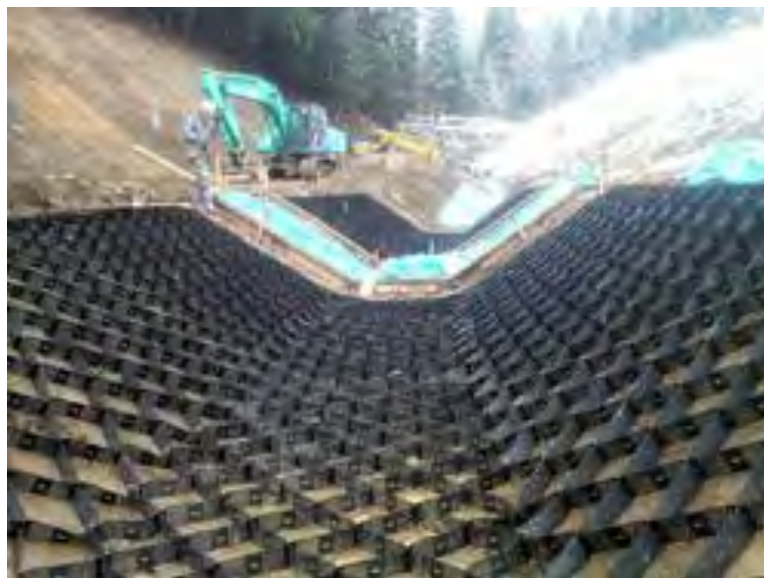
**Area #1:** was described as “The rear of 338-342 New Mark Esplanade (NME). The low area where runoff has created several water paths that are exposing tree roots and creating erosion channels”.

**Recommendation:** Have an arborist review all the trees and remove any suspect/questionable trees. Install a retaining wall at the rear of 338 NME to alleviate ongoing erosion. Within the swale, clear out existing dead trees/debris/and saplings. Install GeoWeb (see photograph below). Install two or more stone check dams to slow / detain water in the swale. It is important to slow the water but not hold it long enough to breed mosquitos. Modify the slope of the swale as necessary to ensure that water reaches the pipe that extends beneath the street. This should continue back as far as the bike path.

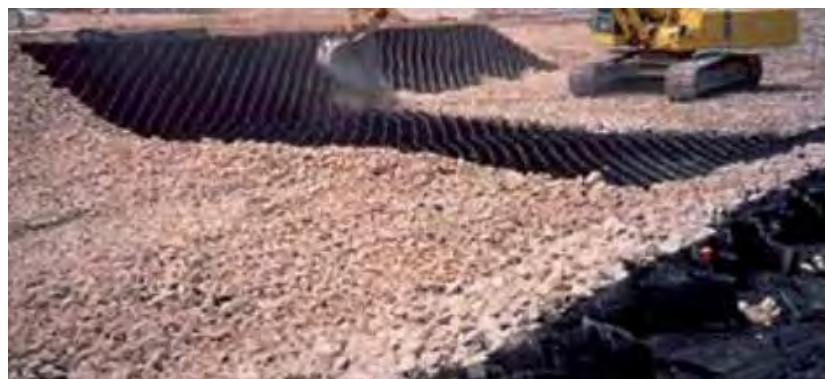
**Area #2:** was described as “Contributing to the Area #1 problem is the wooded area on the side of 508 and 516 NME. Runoff from the parking lot has created erosion channels which have impacted the area behind 338-342 NME”

**Recommendation:** Adjacent to 508 NME, we recommend removing the tree at the parking lot SWM outlet. The RCP is likely to be damaged and may require replacement. The swale should be reconfigured to more efficiently collect and retain water. Install GeoWeb in the swale to prevent erosion. Direct water to the existing, rock-lined swales along the bike path. Due to shade from the heavy tree canopy in area, a vegetated swale is likely not feasible. Accordingly, the photograph below depicts GeoWeb with stone.

Adjacent to 516 NME, we recommend a similar scope of work. We recommend creating a swale to capture the water that outfalls at the cut in parking lot curb. The swale would direct water to the existing rock-lined swales along the bike path. Some tree removal will be required to allow for the installation of the new swale.

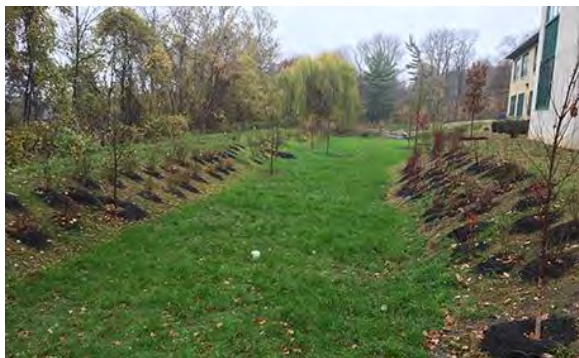
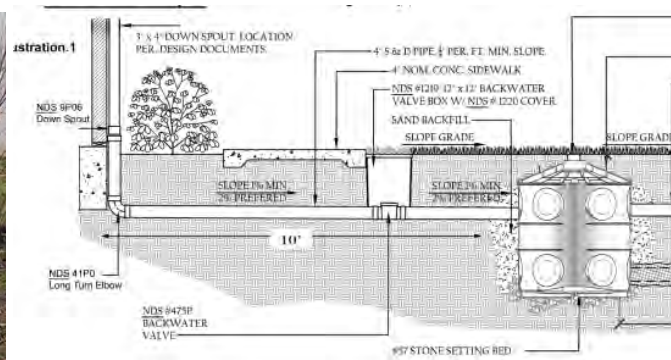
**Area #3:** was described as “The area behind 300-314 NME, concentrating on the area behind 300-306 NME. Storm water runoff from the area between the bike path and the rear of these homes needs to be mitigated.”

**Recommendation:** The issue is not that water cannot reach the area but rather that it picks up debris and clogs the storm drain grate. We recommend a thorough cleaning/jetting of the SWM in this area and more frequent cleanup of debris (i.e. leaves, sticks, etc.) to help prevent accumulation at the grate. We would also propose implementing Flowells to capture a portion of the runoff from the adjacent roof areas. Alternate items to prevent water from reaching the storm drain can be considered if the problem persists. Foremost among these would be a detention / infiltration basin. An infiltration basin would be designed to collect and infiltrate water over a period of two to three days, but not long enough to allow insect breeding or to require ongoing maintenance such as aeration. The photograph below shows a vegetated infiltration basin which functions by having water-loving plants absorb the collected water. As noted above, the current tree cover would prevent these plants from thriving in a similar structure at New Mark Commons.

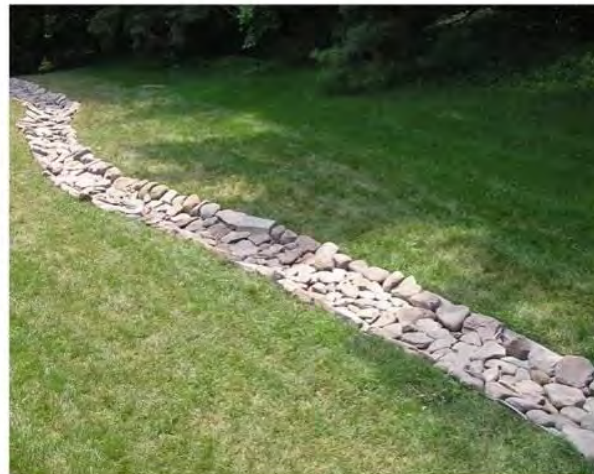
**Area #4:** was described as “The hill side next to 276 NME requires stabilization, additional planting, and an existing surface drain needs to be repaired.”

**Recommendation:** Due to the steep slope in the area, one surface drain is insufficient to capture the runoff. Accordingly, we recommend that a series of gravel swales be installed to divert water into the existing channel on the boundary line. One of the swales could extend to capture the water to the north of 276 NME. The photograph below is an example of such a swale. The residence 276 NME has been identified, by NMC, specifically as requiring a retaining wall. A retaining wall could be installed, however there are several factors to consider. These include the wall's location on residential versus common area property, tree removal to allow for the wall installation, and below-grade waterproofing of the foundation wall of the residence with re-grading. If there are ongoing concerns related to house-settling, a retaining wall may not be the solution. We recommend resolving those items prior to commencing with installation of a retaining wall.

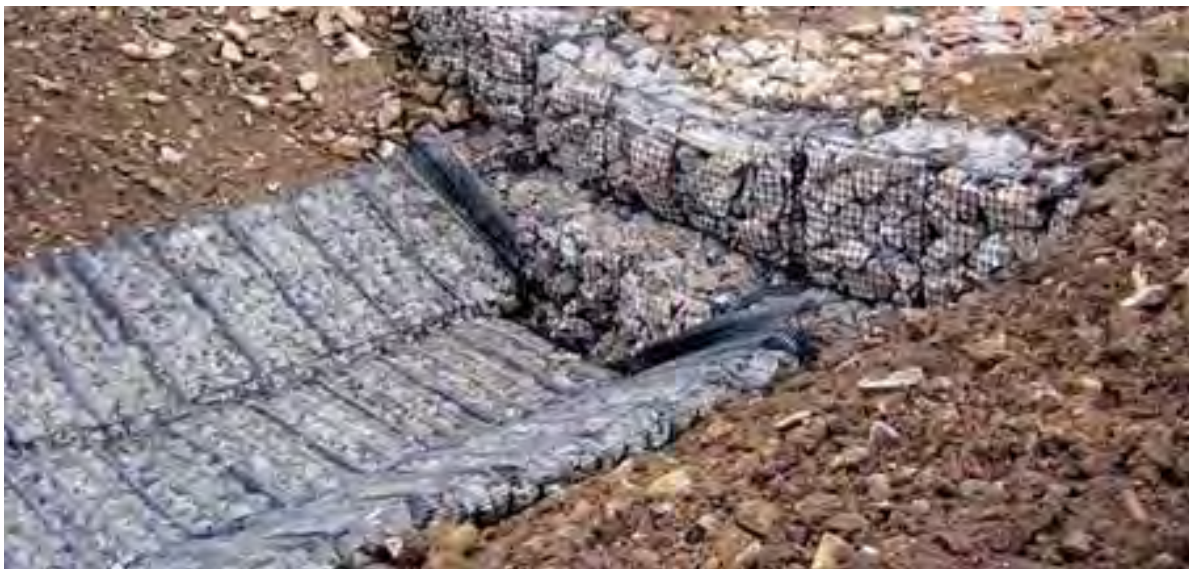
**Area #5** (not on original list): is the stabilization of the swale at the transition to the Fireside Park Apartments, close to 276 NME.

**Recommendation:** This area is likely the worst condition that we observed at New Mark Commons. The area needs to be cleaned of debris and subsequently stabilized. We recommend doing this with gabions and/or large boulders in conjunction with a series of check dams. As this area abuts the adjacent property, it will be necessary to coordinate with the owner for access to make the repairs.

The photograph below shows the use of gabions for stabilizing a stream bank. This particular location at New Mark Commons appears to be routinely subjected to very high volume / high velocity flow. As a result, we are recommending a robust solution. The location is low-visibility, so we are recommending the use of gabions. Gabions are a less aesthetically attractive solution than a segmental retaining wall. They are also a significantly lower cost and accordingly a more suitable product for this location.
